**Flood Control Project Maintenance
Levee Inspections**
LMA District Cover Sheet
Spring 2020 Levee Inspection Results

Yolo County Service Area 6

Spring 2020 Levee Inspection Results

Waterway			Bank	Unit Miles
Unit No. 01 Right Bank of Sacramento River at Knights Landing			Right	5.87
	Spring (March - May)	Summer (June - August)	(September - November) Fall	Winter (December - February)
Unit Maintenance Rating (Fall Only)				
Date of Inspection	3/19/2020 - 3/19/2020			
DWR Inspector	Zach Jojola			
Accompanied By	Thomas Engler MBK

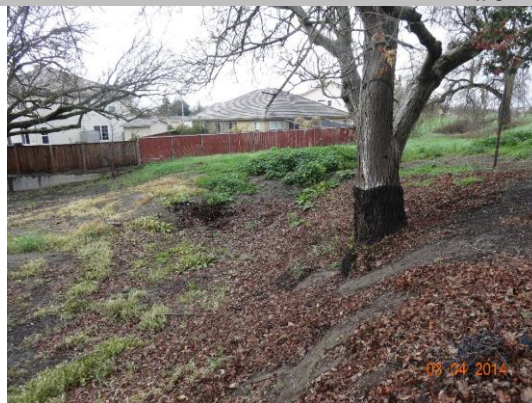
Photo 1 of 3 : UCIP_SP_2020_31903_58222.jpg

Comment Code						
Inspector Comment						
DS_ID:19515 FS_ID:31903 EP_NO: 9425 Repair Type: Non-Urgent Crossing Status: Found UCIP Comments: Need to properly abandon crossing per Title 23-- pipe has been disconnected. No signs of pipe visible on waterward and landward sides. Need to contact owner to determine additional information about pipe section through levee. FIELD_STRUCT_DESC: *ABANDONED* 8-inch steel irrigation discharge pipe through the levee, 3 feet below the crown. Pump structure in the channel. 8-inch pipe replaced by a 4-inch pipe. (Retention of an 8-inch steel pipe through the levee and a pump on a platform on the waterside [WS] authorized under Automatic Board Order (ABO) issued as Permit No. 9425, 1974 - Albert E. Nuttall). [Additional Reference(s): DWR Levee Log, 2005]. FS Date: 3/4/2014

View of landward side.

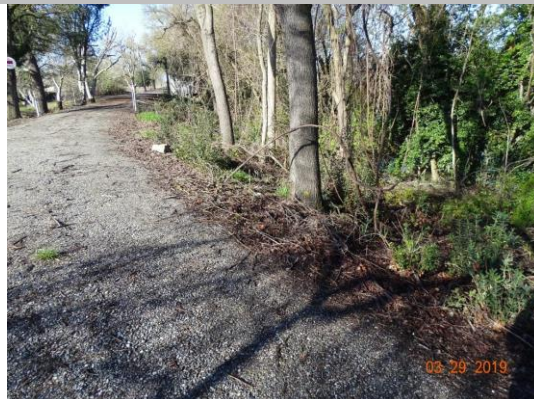
Photo 1 of 1 : SP_2020_NA0022_350_43_20200228_00021.jpg

View of vegetation on the waterside slope. Spring 2019.

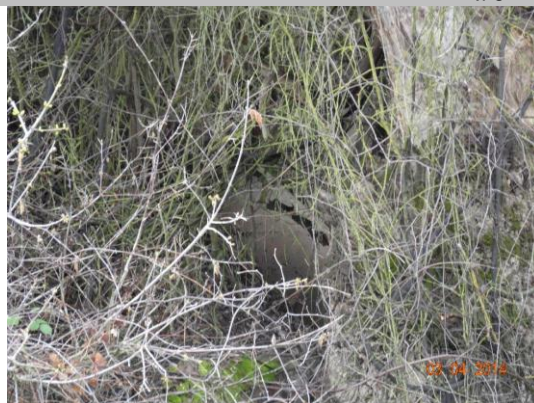
Photo 1 of 3 : UCIP_SP_2020_31904_58228.jpg

LM Start	0.21	Rating **	M	Issue No.	397
LM End	0.21	Issue Type +	En	Location *	
Category	Supplemental			GPS Latitude/Longitude	
				Start	End
Item	DWR UCIP Field Study			38.801280 °	38.801280 °
				-121.722000 °	-121.722000 °
DWR ID	19516				
Comment Code					
Inspector Comment					
DS_ID:19516 FS_ID:31904 EP_NO: N/A Repair Type: Non-Urgent Crossing Status: Indicator Found UCIP Comments: Need to properly abandon per Title 23 if corssing is no longer used--debris inside concrete box and near site. Need to contact owner. FIELD_STRUCT_DESC: 48-inch corrugated metal gravity drainage pipe through the levee, 14.5 feet below the crown. Slide gate in a concrete box on the waterside (WS) bank. (Automatic Board Order (ABO) issued as Permit No. Unknown, 1976 - Wallace) [Additional Reference(s): DWR Levee Log, 2005]. FS Date: 3/4/2014

Pipe section with holes abandoned on waterward side.

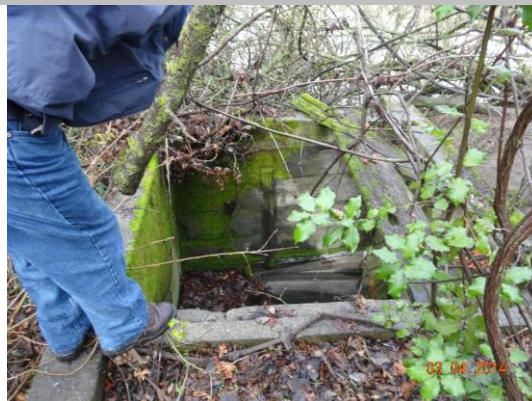
Photo 3 of 3 : UCIP_SP_2020_31904_58226.jpg

Concrete box located on waterward side.

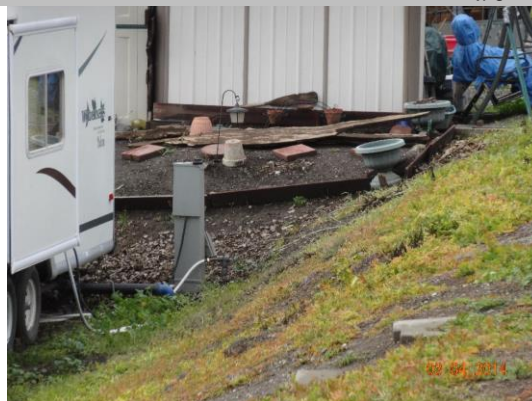
Photo 2 of 3 : UCIP_SP_2020_45403_60804.jpg

Spigot located on landward toe.

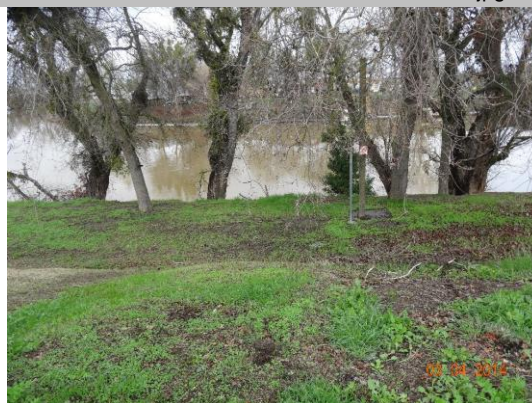
Photo 3 of 3 : UCIP_SP_2020_45403_60803.jpg

View of waterward side.

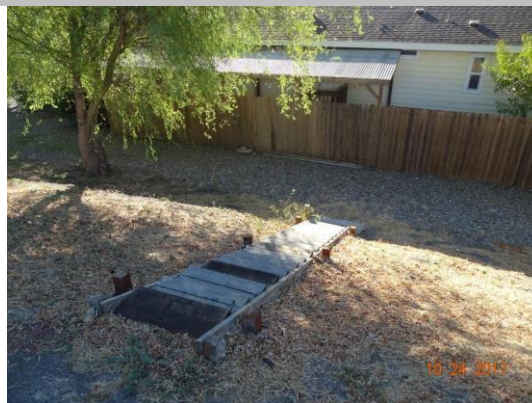
Photo 1 of 1 : SP_2020_NA0022_350_61_20200228_00029.jpg

View of stairs on landside slope. Fall 2017.

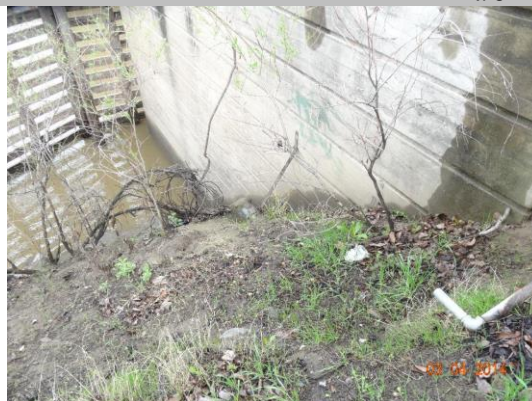
Photo 1 of 2 : UCIP_SP_2020_31906_58238.jpg

DS_ID:19534
FS_ID:31906
EP_NO: 17016
Repair Type: Non-Urgent
Crossing Status: Indicator Found
UCIP Comments: Unable to confirm crossing alignment--steel pipe visible on waterward side however, unable to confirm if crossing is the same one found during field confirmation. Need to contact owner to verify alignment and status of crossing. Slope was too steep to verify and obtain additional information about pipe.
FIELD_STRUCT_DESC: Three 2-inch and three 1.5-inch fiber optics conduits through the levee, encased in a single high-density polyethylene (HDPE) casing, 30 feet below the crown. Concrete cap on each end of the HDPE casing. Voids in the HDPE casing grouted. (Plans to install three 2-inch and three 1.5-inch fiber optics conduits within a casing across and bored under the Sacramento River and its levees authorized under Permit No. 17016, 2000 - Worldwide Fiber).
FS Date: 3/4/2014

Steel pipe located on waterward side--pipe disconnected.

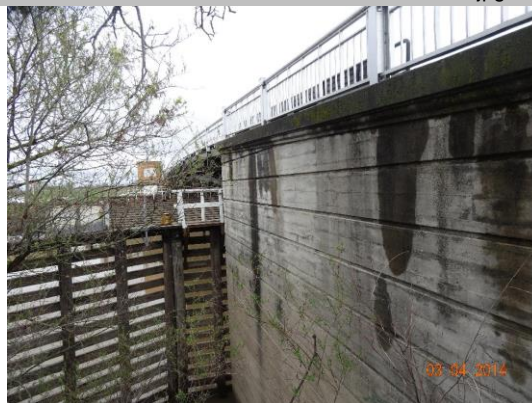
Photo 2 of 2 : UCIP_SP_2020_31906_58237.jpg

No pipe attached along bridge.

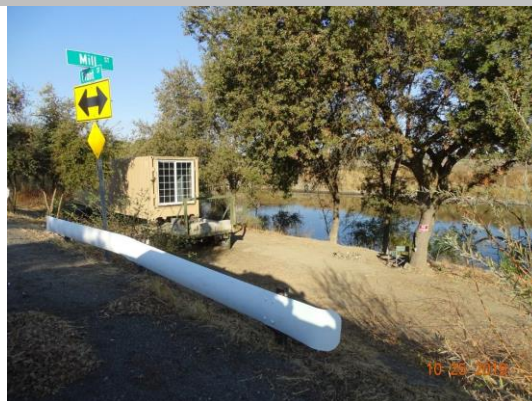
Photo 2 of 3 : SP_2020_NA0022_350_71_20200228_00033.jpg

View of the connex box facing upstream on the Sacramento River. Fall 2019.

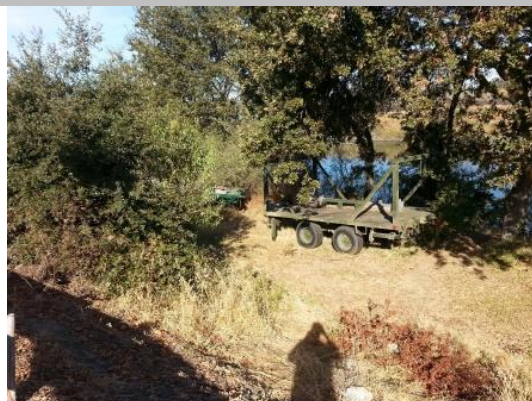
Photo 3 of 3 : SP_2020_NA0022_350_71_20200228_00034.jpg

Vehicles and equipment on waterward side of the levee. Fall 2016.

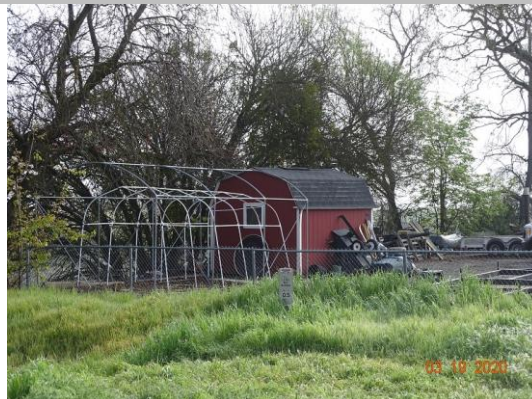
Photo 1 of 1 : SP_2020_NA0022_350_395_20200319_00122.jpg

View of equipment on the waterside berm. Spring 2020.

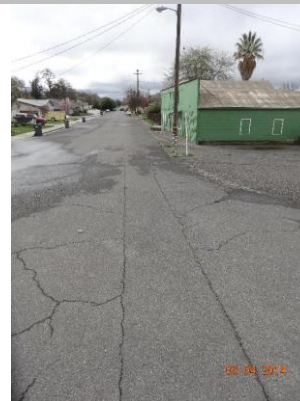
Photo 1 of 3 : UCIP_SP_2020_31627_57881.jpg

LM Start	0.51	Rating **	M	Issue No.	400
LM End	0.51	Issue Type +	En	Location *	
Category	Supplemental			GPS Latitude/Longitude	
				Start	End
Item	DWR UCIP Field Study			38.802062 °	38.802062 °
				-121.716740 °	-121.716740 °
DWR ID	19544				
Comment Code					
Inspector Comment					
DS_ID:19544 FS_ID:31627 EP_NO: N/A Repair Type: Non-Urgent Crossing Status: Indicator Found UCIP Comments: Unable to confirm if signs of crossing are for the same crossing listed here. Need to contact owner and determine additional information about crossing. Also found is service box for water line--need permit and alignment confirmation. FIELD_STRUCT_DESC: 10-inch steel pipe of an unknown purpose through the levee, at an unknown depth. [Additional Reference(s): DWR Levee Log, 2005. USACE Sacramento O&M Manual 127, June 1953, (Station 285+27)]. FS Date: 3/4/2014

View of landward side. Alignment is visible on paved road.

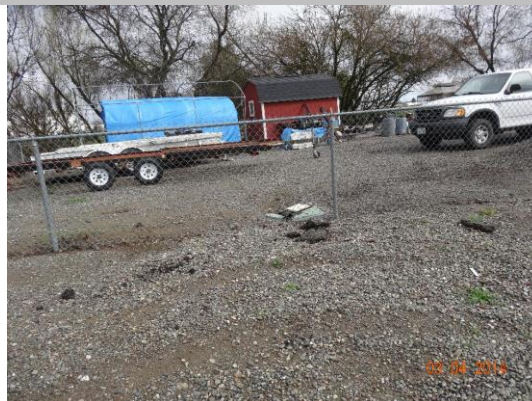
Photo 3 of 3 : UCIP_SP_2020_31627_57879.jpg

Service box located on waterward side near fence post.

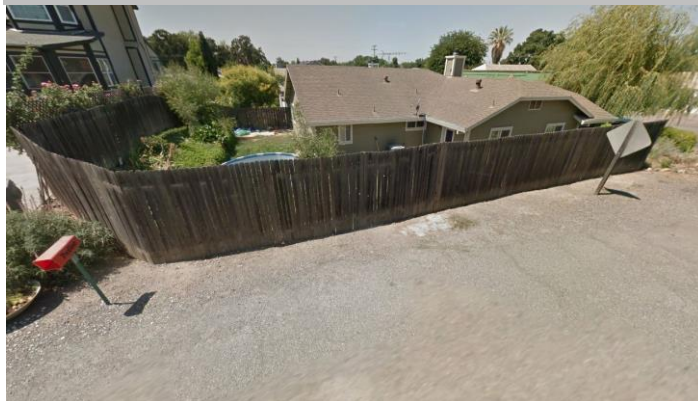
Photo 1 of 1 : SP_2020_NA0022_350_63_20200401_00124.jpg

LM Start	0.52	Rating **	U	Issue No.	63
LM End	0.53	Issue Type +	En	Location *	LS
Category	Earthen Levee			GPS Latitude/Longitude	
				Start	End
Item	Encroachments			38.801980 °	38.801929 °
				-121.716502 °	-121.716330 °
DWR ID	DWR_NA0022_01_f _ 2017_63				
Comment Code					
FE : Fence					
Inspector Comment

View of fence at the landside toe. Spring 2020.

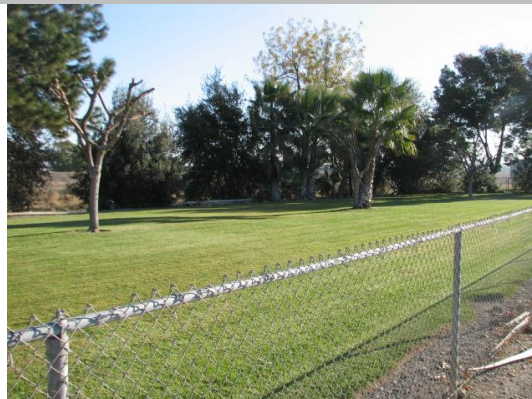
Photo 1 of 1 : SP_2020_NA0022_350_24_20200228_00010.jpg

View of chain link fence on crown. Fall 2013.

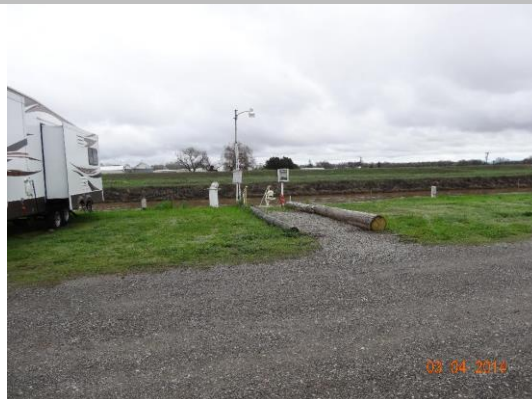
Photo 1 of 3 : UCIP_SP_2020_38188_69562.jpg

Comment Code					
Inspector Comment					
DS_ID:19519 FS_ID:38188 EP_NO: N/A Repair Type: Non-Urgent Crossing Status: Indicator Found UCIP Comments: Unable to find any signs of crossing on waterward side. Signs of concrete riser visible on landward side. If crossing is abandoned owner will need to coordinate with the Central Valley Flood Protection Board (CVFPB) for Title 23 requirements. FIELD_STRUCT_DESC: 10-inch pipe of an unknown material or purpose through the levee, 3.3 feet below the crown. 24-inch concrete riser on the landside (LS). Plate welded on the waterside (WS) end in 1975. [Additional Reference(s): DWR Levee Log, 2005]. FS Date: 3/4/2014

View of waterward side.

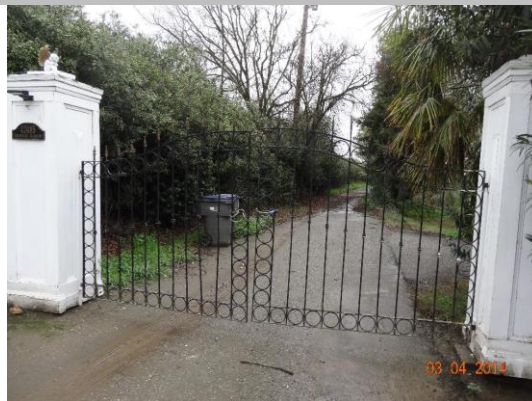
Photo 3 of 3 : UCIP_SP_2020_38188_69561.jpg

Residential property standpipe located behind fence.

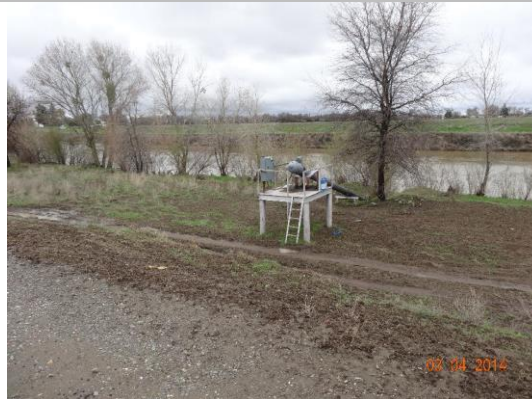
Photo 1 of 3 : UCIP_SP_2020_31969_58410.jpg

Comment Code					
Inspector Comment					
DS_ID:19540 FS_ID:31969 EP_NO: N/A Repair Type: Non-Urgent Crossing Status: Found UCIP Comments: Pipe section on waterward side appears to have been removed and reinstalled--Need to contact owner to obtain additional information regarding work completed. FIELD_STRUCT_DESC: 14-inch steel irrigation discharge pipe through the levee, 4.6 feet below the crown. Pump and valve on the riverbank. See DS_ID 19521. (Plans for installation of an angle mount low-lift pump and structure to replace an existing portable pumping plant, which will be connected to the existing 14-inch discharge pipe through the levee authorized under Permit No. 3798, 1961 - Alta Morris). [Additional Reference(s): USACE Sacramento O&M Manual 127, June 1953, (Station 266+72.2)]. FS Date: 3/4/2014

View of waterward side.

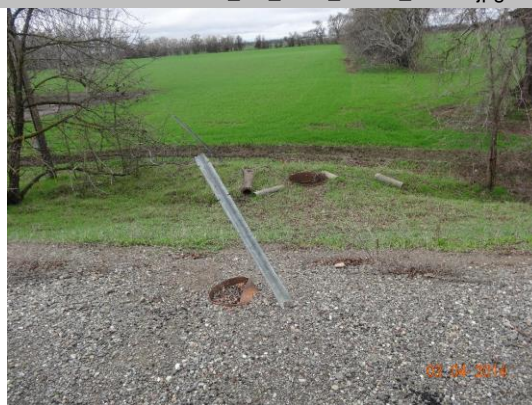
Photo 1 of 3 : UCIP_SP_2020_31912_58261.jpg

Comment Code						
Inspector Comment						
DS_ID:19522 FS_ID:31912 EP_NO: 6296 Repair Type: Non-Urgent Crossing Status: Found UCIP Comments: Siphon breaker housing on landward slope unit damaged and debris scattered on landward side. Unable to determine if crossing is still in use. Need to contact owner to determine status of crossing. FIELD_STRUCT_DESC: 12-inch (not 14-inch as indicated in the desk study) coated steel irrigation discharge pipe through the levee, 11.8 feet below the crown. Standard corrugated metal cutoff wall around pipe at centerline of levee. 1.25-inch electrical conduit through the levee. Electrical control panel on the waterside (WS) slope. Slant pump mounted on a steel structure on the riverbank. Siphon breaker on the landside (LS) shoulder. Pipe extends from pump to existing irrigation ditch at the LS toe. (Plans to install a pump and pipe through the levee authorized under Permit No. 6296, 1968 - Emma Collier). [Additional Reference(s): DWR Levee Log, 2005]. FS Date: 3/4/2014

View of landward side.

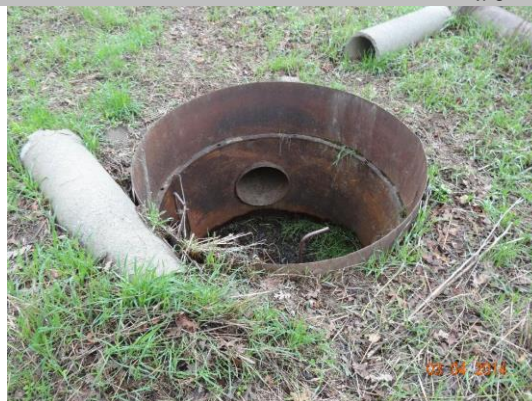
Photo 2 of 3 : UCIP_SP_2020_31912_58260.jpg

Riser on landward toe.

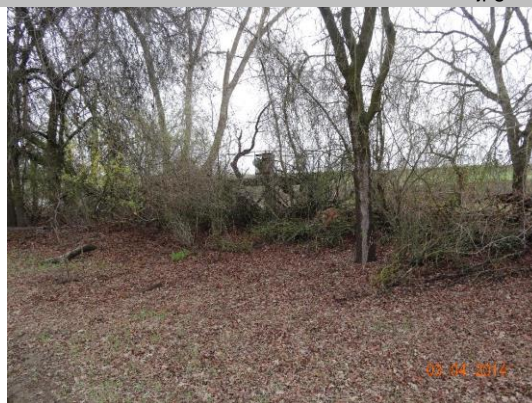
Photo 3 of 3 : UCIP_SP_2020_31912_58259.jpg

View of waterward side.

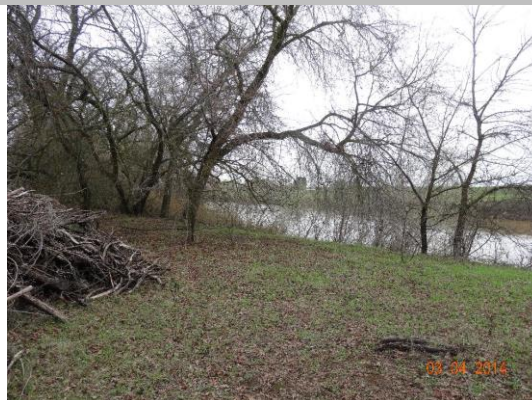
Photo 2 of 3 : UCIP_SP_2020_38190_69565.jpg

View of waterward side.

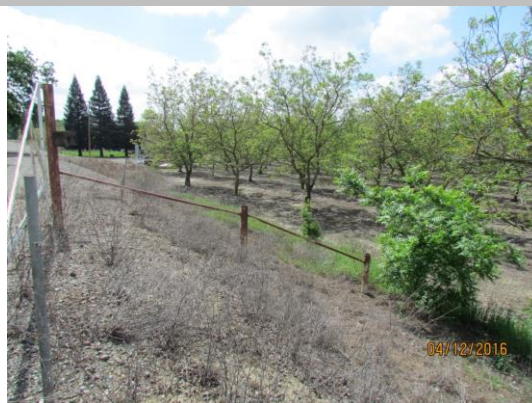
Photo 1 of 1 : SP_2020_NA0022_350_112_20200228_00047.jpg

View of the tree at the toe of the levee on the landward side looking downstream. Spring 2016.

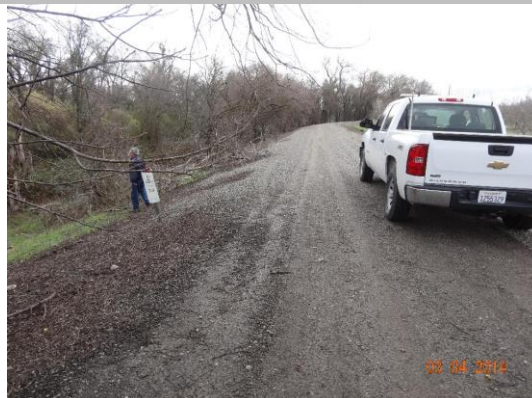
Photo 2 of 3 : UCIP_SP_2020_40536_58264.jpg

Comment Code						
Inspector Comment						
DS_ID:19524 FS_ID:40536 EP_NO: 9413 Repair Type: Non-Urgent Crossing Status: Found UCIP Comments: Alignment through levee unknown--no signs of crossing through landward side. Need to contact owner to determine status of crossing. This crossing appears to have been updated since 1970s. FIELD_STRUCT_DESC: 24-inch pipe of an unknown material or purpose through the levee, 15.5 feet below the crown. Gate valve on the landside (LS) end. Ramp on the waterside (WS) slope. (Retention of a 30-inch pipe through the levee and a slide gate in a corrugated metal pipe [CMP] riser on both slopes authorized under Automatic Board Order (ABO) issued as Permit No. 9413, 1974 - Wallace Construction Company). Added appurtenances noticed in 2014: pump, metal frame platform, flow meter, and control panel on the WS. Appurtenances could be associated with Permit No. 12804. This appears to be the same entry as DS_ID 19538. [Additional Reference(s): DWR Levee Log, 2005]. FS Date: 3/4/2014

View of levee crown at crossing.

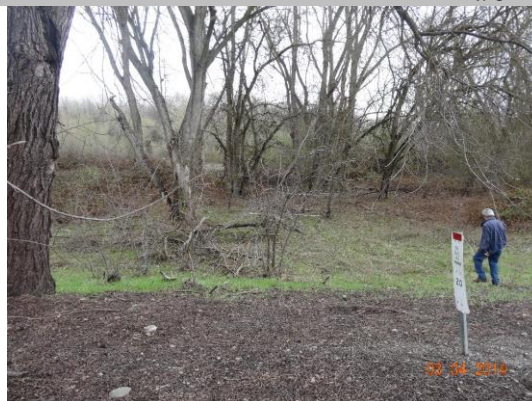
Photo 3 of 3 : UCIP_SP_2020_40536_58263.jpg

View of waterward side.

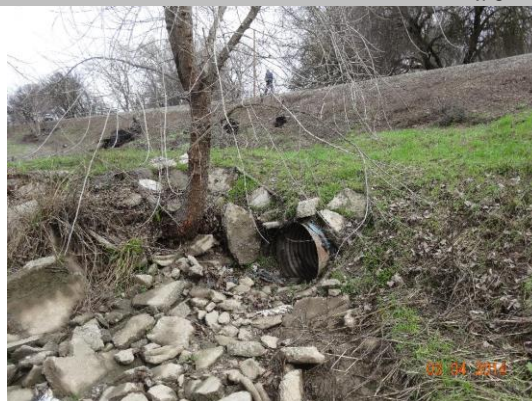
Photo 1 of 3 : UCIP_SP_2020_31632_57905.jpg

DS_ID:19523
FS_ID:31632
EP_NO: 9413
Repair Type: Non-Urgent
Crossing Status: Indicator Found
UCIP Comments: Erosion at outlet. Unable to determine if crossing is still in use. Will need to contact owner to determine status of crossing.
FIELD_STRUCT_DESC: 30-inch corrugated metal gravity irrigation pipe through the levee, 13.5 feet below the crown. Slide gate on each end in a 48-inch corrugated metal pipe (CMP) riser. (Retention of a 30-inch pipe through the levee and a slide gate in a corrugated metal pipe [CMP] riser on both slopes authorized under Automatic Board Order (ABO) issued as Permit No. 9413, 1974 - Wallace Construction Company. Plans to relocate an existing incline irrigation pumping plant authorized under Permit No. 12804, 1979 - Wallace Construction Company). Pumping plant appears to be located at CLM 1.969, and pipe runs along the waterside (WS) berm and discharges into a ditch where the 30-inch pipe is used to convey the irrigation water to the landside (LS). [Additional Reference(s): DWR Levee Log, 2005].

Outlet located on landward toe.

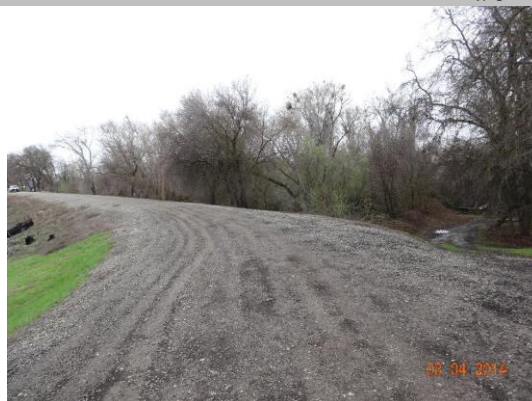
Photo 2 of 3 : UCIP_SP_2020_31632_57903.jpg

Overview of levee crown at crossing.

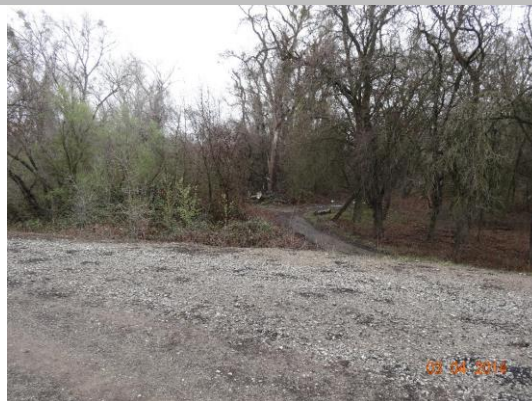
Photo 3 of 3 : UCIP_SP_2020_31632_57904.jpg

View of waterward side.

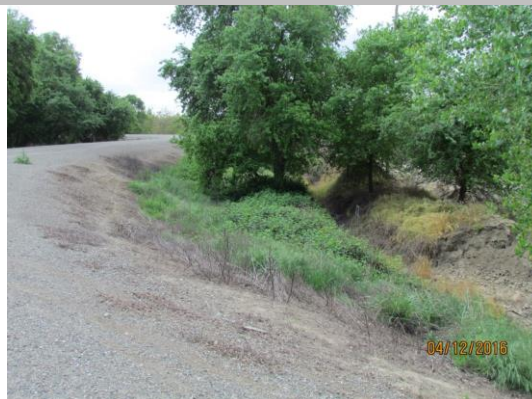
Photo 1 of 1 : SP_2020_NA0022_350_7_20200228_00002.jpg

View of the ditch at the levee toe on the landward side looking downstream. Spring 2016.

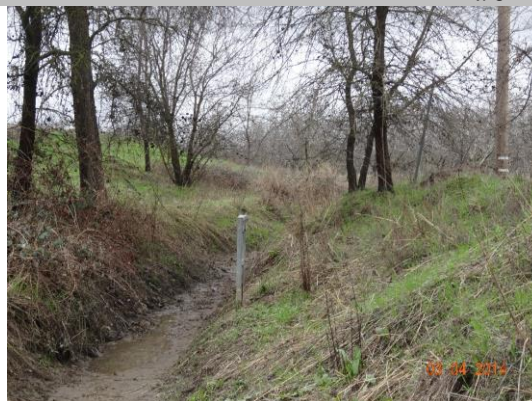
Photo 1 of 3 : UCIP_SP_2020_31915_58270.jpg

Comment Code						
Inspector Comment						
DS_ID:19538						
FS_ID:31915						
EP_NO: N/A						
Repair Type: Non-Urgent						
Crossing Status: Indicator Found						
UCIP Comments: Buried gate valve on landward slope. Crossing appears to be non-functional. Landward pipe section across canal has deteriorated. Will need to contact owner to determine status of crossing. If crossing is not in use owner will need to contact the CVFPB to abandon properly according to Title 23.						
FIELD_STRUCT_DESC: 20-inch corrugated metal gravity drainage pipe through the levee, at an unknown depth. 20-inch gate valve on the landside (LS) slope. This crossing could be the same record as DS_ID 19524 - unable to confirm. [Additional Reference(s): USACE Sacramento O&M Manual 127, June 1953, (Station 208+15)].						
FS Date: 3/4/2014

Slide gate inside canal.

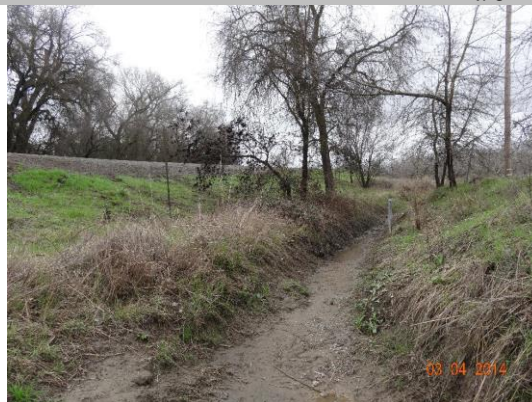
Photo 2 of 3 : UCIP_SP_2020_31915_58269.jpg

View of canal runs parallel on landward toe.

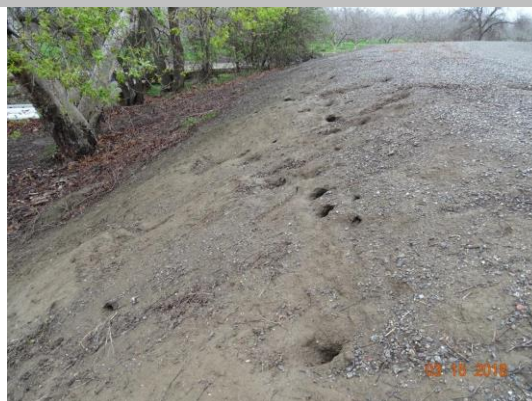
Photo 1 of 2 : SP_2020_NA0022_350_8_20200228_00003.jpg

View of rodent holes on the landside slope. Spring 2018.

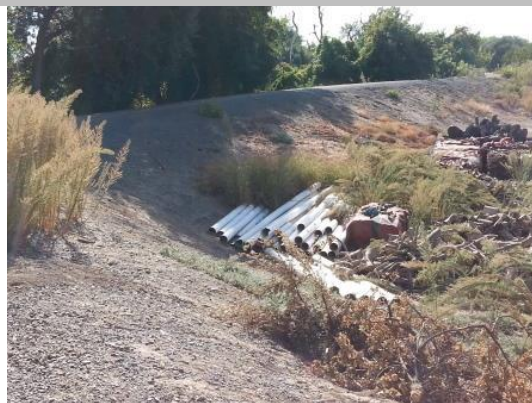
Photo 1 of 1 : SP_2020_NA0022_350_40_20200228_00019.jpg

View of the equipment on landward side. Fall inspection 10/07/2016.

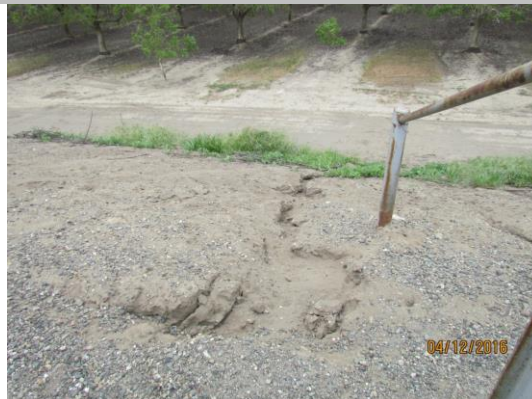
Photo 1 of 2 : SP_2020_NA0022_350_35_20200228_00014.jpg

Erosion is on the landward side of the levee. Spring 2016.

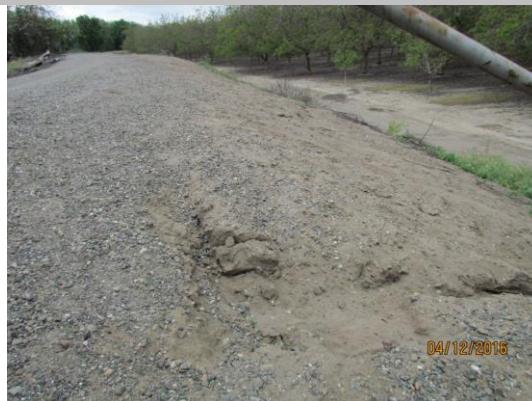
Photo 2 of 2 : SP_2020_NA0022_350_35_20200228_00015.jpg

Perspective view of the erosion on the landward side of the levee. Spring 2016.

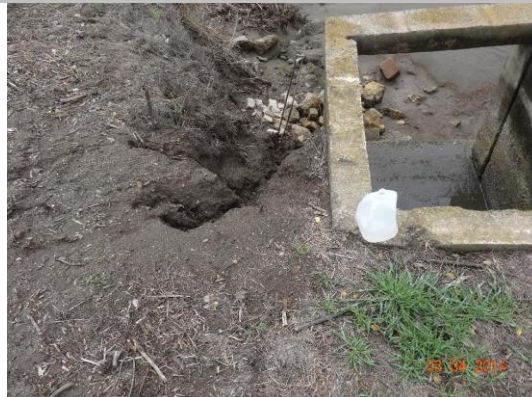
Photo 2 of 3 : UCIP_SP_2020_52726_57914.jpg

Slope erosion near concrete box.

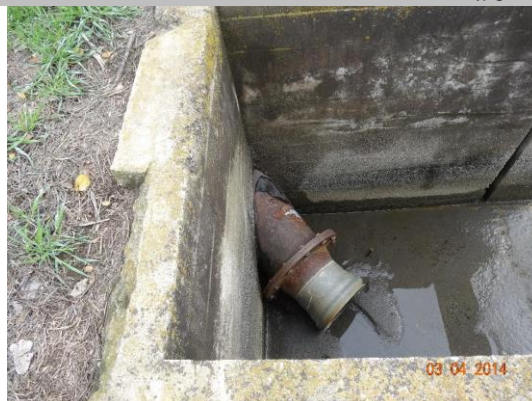
Photo 3 of 3 : UCIP_SP_2020_52726_57913.jpg

Outlet located on LS.

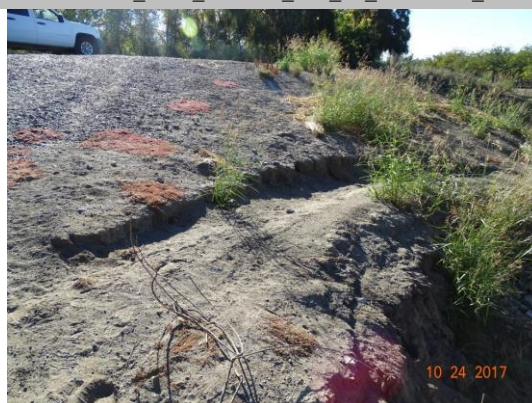
Photo 1 of 4 : SP_2020_NA0022_350_96_20200228_00042.jpg

View of erosion on landside slope. Fall 2017.

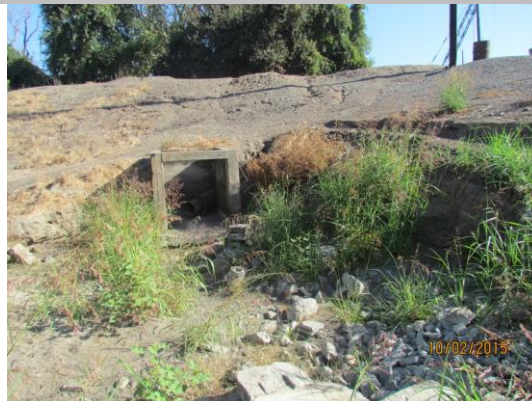
Photo 3 of 4 : SP_2020_NA0022_350_96_20200228_00044.jpg

The erosion is within the levee prism. Fall 2015.

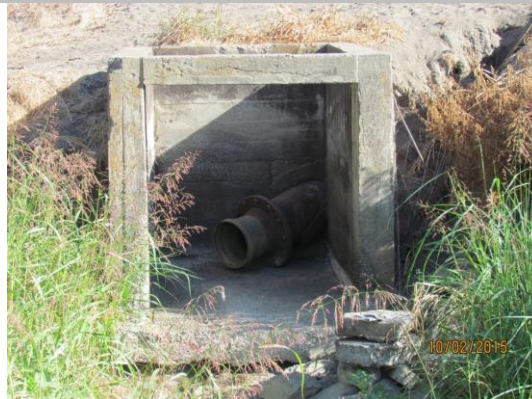
Photo 4 of 4 : SP_2020_NA0022_350_96_20200228_00045.jpg

View of the pipe in the concrete box. Fall 2015.

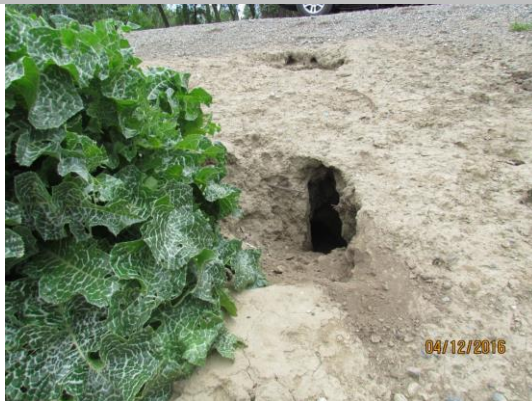
Photo 1 of 2 : SP_2020_NA0022_350_123_20200228_00052.jpg

View of the rodent hole next to a tree stump on the landward side of the levee. Spring 2016.

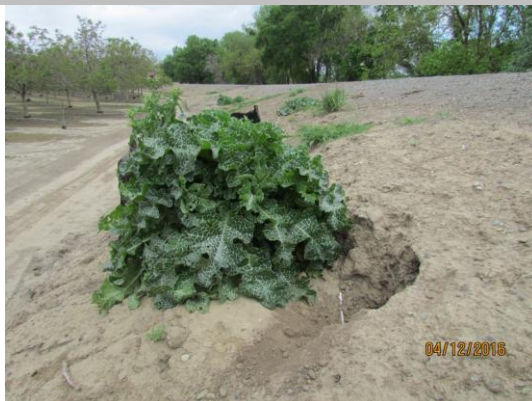
Photo 2 of 2 : SP_2020_NA0022_350_123_20200228_00053.jpg

Perspective view of the rodent hole looking upstream. Spring 2016.

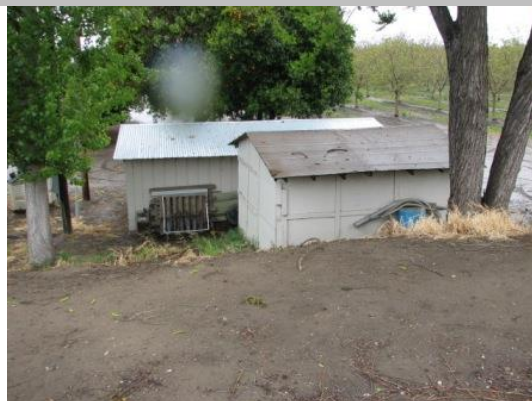
Photo 1 of 1 : SP_2020_NA0022_350_11_20200228_00005.jpg

Garage at toe.

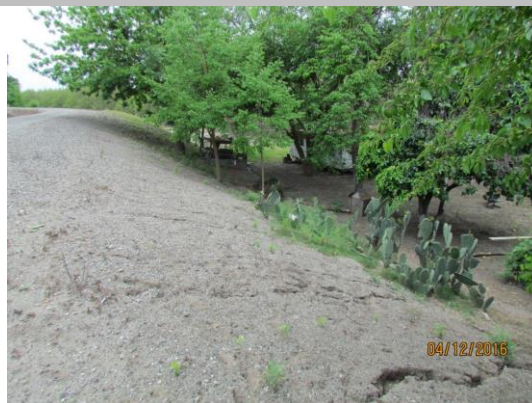
Photo 1 of 1 : SP_2020_NA0022_350_124_20200228_00054.jpg

View of the cacti and trees at the toe of the levee on the landward side looking downstream. Spring 2016.

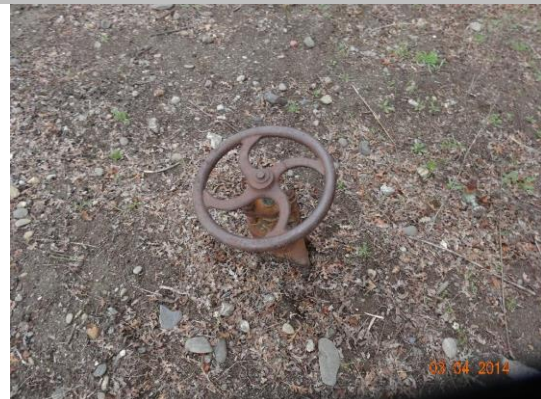
Photo 2 of 3 : UCIP_SP_2020_39858_71840.jpg

Positive closure device is buried on waterward side.

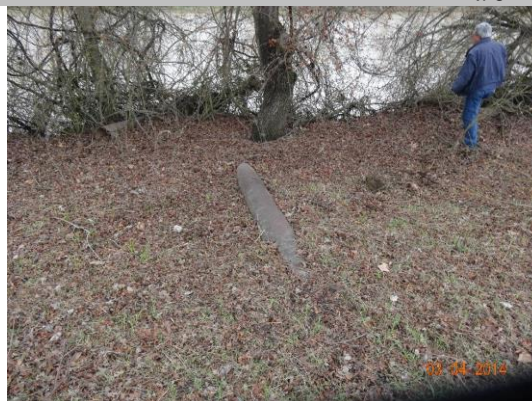
Photo 3 of 3 : UCIP_SP_2020_39858_71845.jpg

Pipe section visible on waterward side.

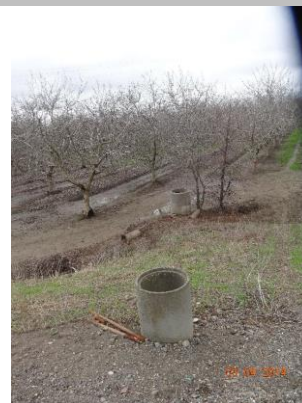
Photo 1 of 3 : UCIP_SP_2020_31916_58275.jpg

View of landward side.

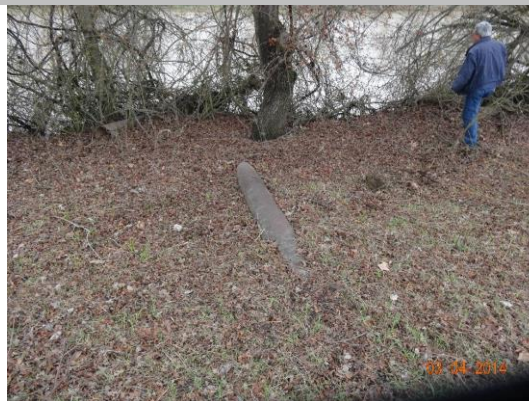
Photo 3 of 3 : UCIP_SP_2020_31916_58273.jpg

Pipe section visible on waterward side.

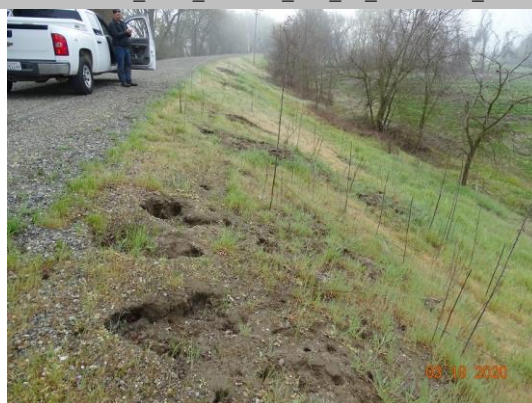
Photo 1 of 1 : SP_2020_NA0022_350_53_20200319_00123.jpg

View of the large rodent holes on the landside slope. Spring 2020.

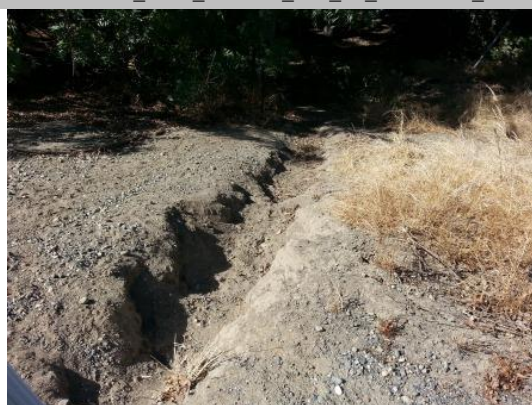
Photo 1 of 3 : SP_2020_NA0022_350_79_20200228_00035.jpg

View of erosion on the landside slope. Fall 2016.

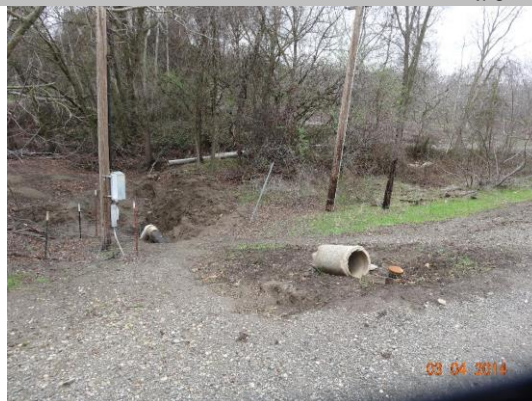
Photo 1 of 3 : UCIP_SP_2020_52727_58279.jpg

View of landward side, photo 1 of 2.

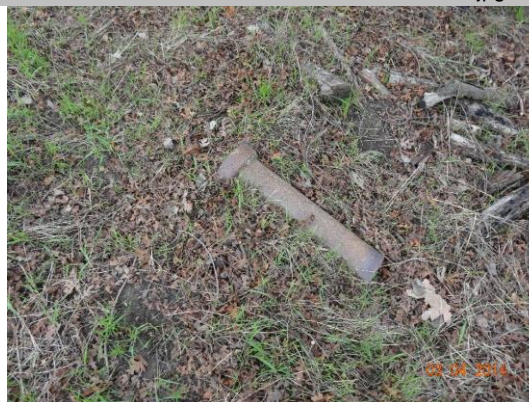
Photo 2 of 3 : UCIP_SP_2020_38996_69567.jpg

Debris scattered on landward side.

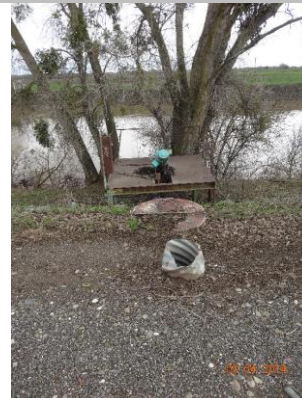
Photo 2 of 3 : UCIP_SP_2020_38999_57947.jpg

View of waterward side.

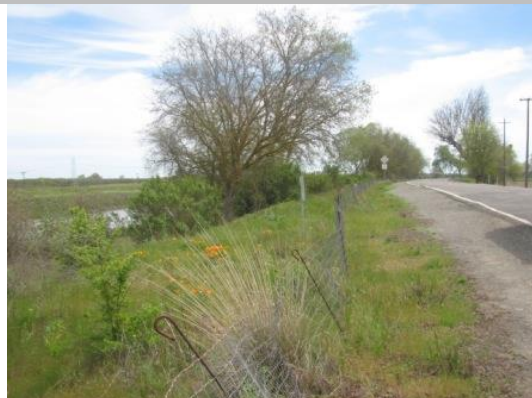
Photo 1 of 2 : SP_2020_NA0022_350_36_20200228_00016.jpg

Another view of the site.

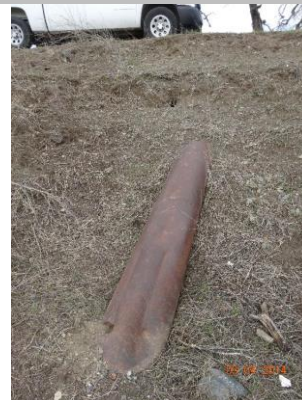
Photo 2 of 3 : UCIP_SP_2020_31986_58439.jpg

Pipe through levee punctured visible on landward slope.

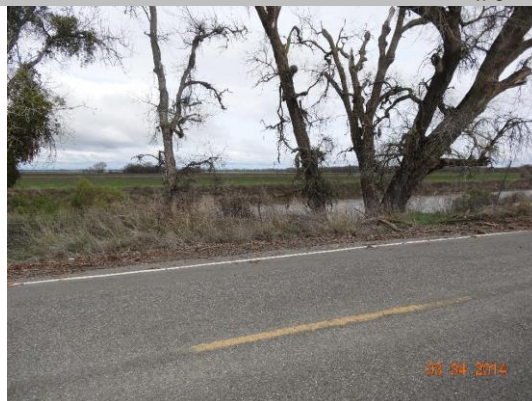
Photo 3 of 3 : UCIP_SP_2020_31986_58441.jpg

View of waterward side.

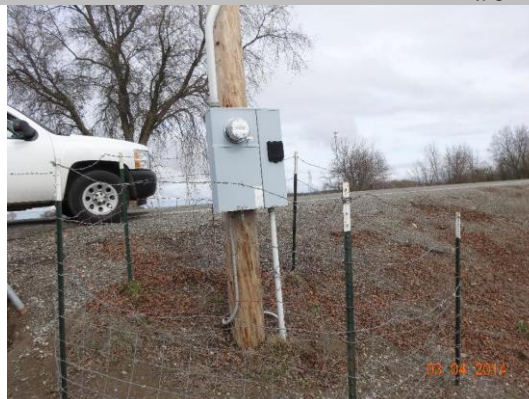
Photo 2 of 3 : UCIP_SP_2020_52728_69572.jpg

Power pole with conduit line through levee.

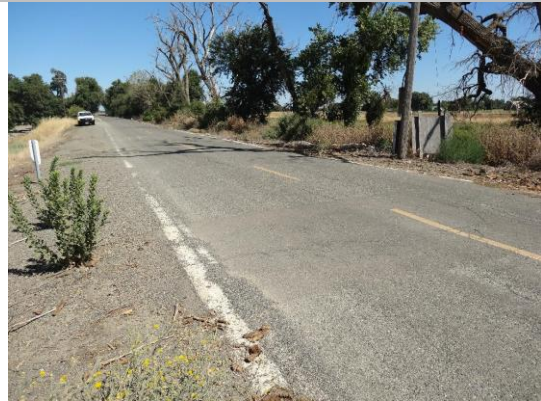
Photo 3 of 3 : UCIP_SP_2020_52728_75759.jpg

Overview of pipe crossing looking upstream.

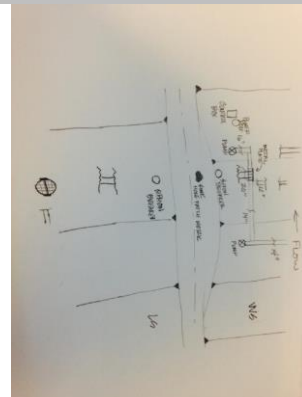
Photo 1 of 3 : UCIP_SP_2020_52729_58451.jpg

Plan view of crossing and appurtenances at CLM 4.692.

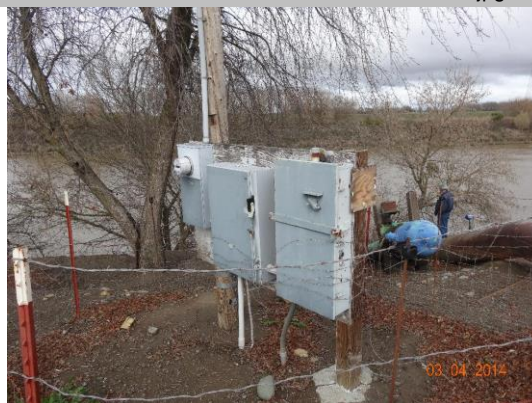
Photo 3 of 3 : UCIP_SP_2020_52729_58459.jpg

Power pole, meter box, & pump control panels located on WS.

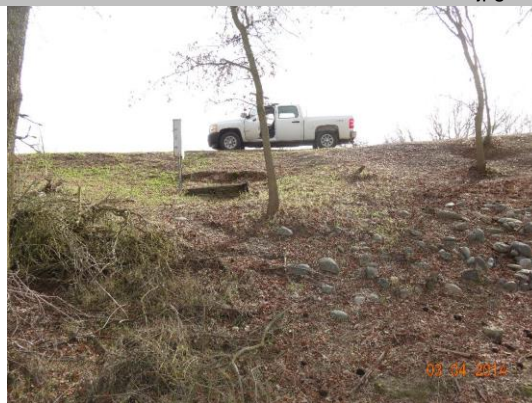
Photo 2 of 3 : UCIP_SP_2020_31927_58331.jpg

Rip rap along waterward slope.

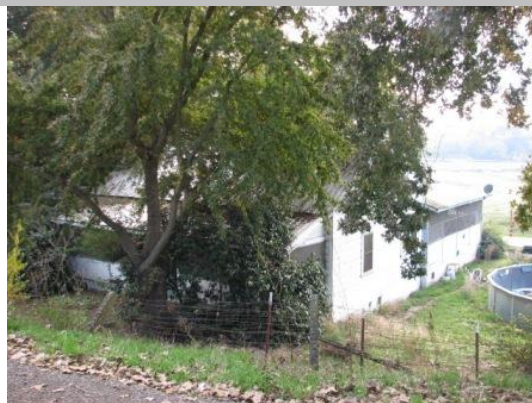
Photo 1 of 1 : SP_2020_NA0022_350_1_20200228_00001.jpg

The house and landscape are in the easment of the levee. Fall 2011

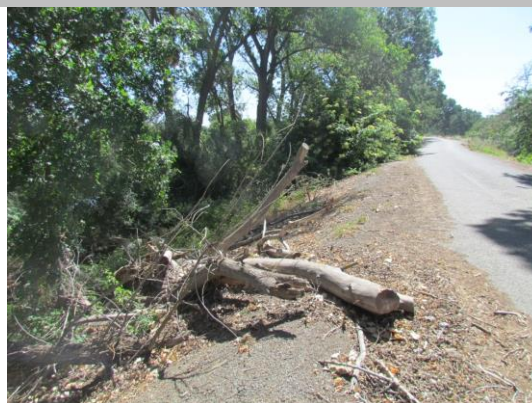
Photo 1 of 1 : SP_2020_NA0022_350_82_20200228_00038.jpg

View of the fallen tree on the waterward side of the levee looking downstream. Spring 2015.

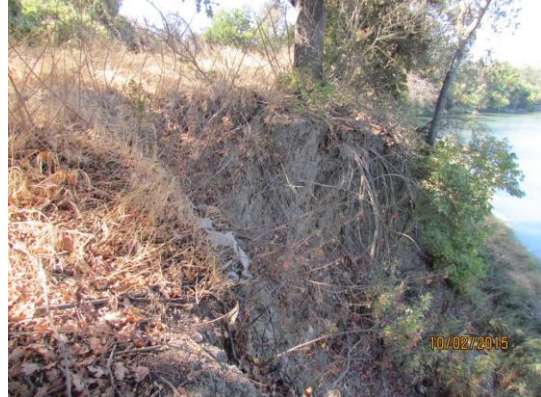
Photo 2 of 3 : SP_2020_NA0022_350_84_20200228_00040.jpg

View of the erosion on the waterward side of the levee looking upstream.
Fall 2015.

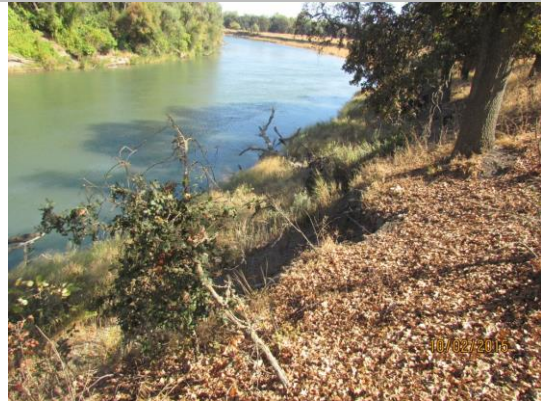
Photo 3 of 3 : SP_2020_NA0022_350_84_20200228_00041.jpg

View of the erosion on the waterward side of the levee looking
downstream. Fall 2015.
